# IRONCORE INSPECTIONS & ENVIRONMENTAL

## RESIDENTIAL PROPERTY INSPECTION

1234 Main Street  
Fort St. John, BC  
Client Name  
06/17/2026 – 9:00 AM

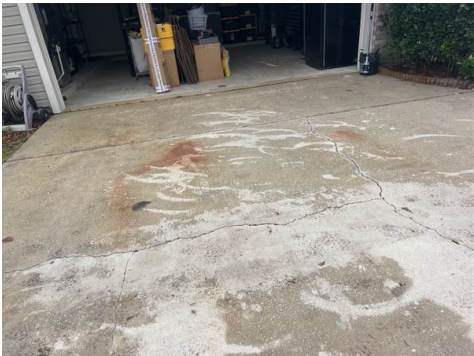
2.2.1 Driveway & Walkway Conditions

DRIVEWAY CRACKING - MINOR

Minor cosmetic cracks observed, which may indicate movement in the soil. Recommend monitor and/or have driveway contractor patch/seal.

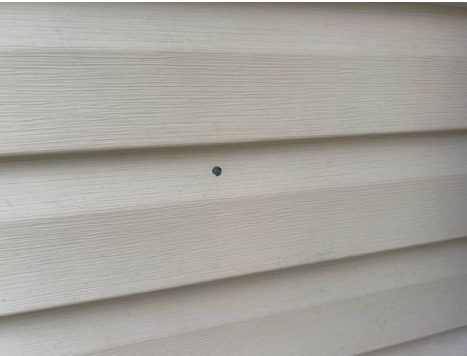
Right rear

SIDING/TRIM DAMAGE PRESENT

Damage was present to the siding and/or trim in one or more areas. Repairs or replacement of damaged portions as deemed necessary by a siding contractor is recommended to prevent moisture infiltration.

Contact a qualified handyman.

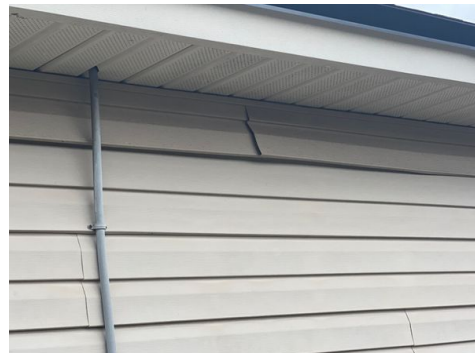
Left rear

Unlocked siding was present. These pieces should be secured, as wind can pull the pieces off or damage them. Proper securement is recommended to be conducted by a qualified person.

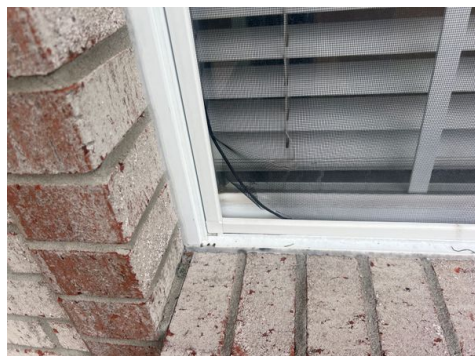
Right

**MISSING/DAMAGED SCREENS**

There are one or more windows with damaged or missing screens. Recommend having a qualified contractor evaluate and repair or replace as needed. Recommend consulting with the seller to see if the screens are present and can be installed.

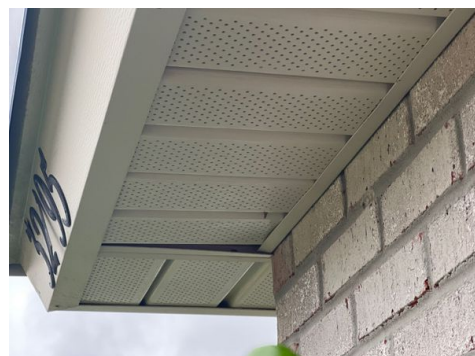
There were gaps present on the fascia at some transitions. Sealing these areas or repairs as needed to prevent moisture infiltration is recommended by a qualified person.

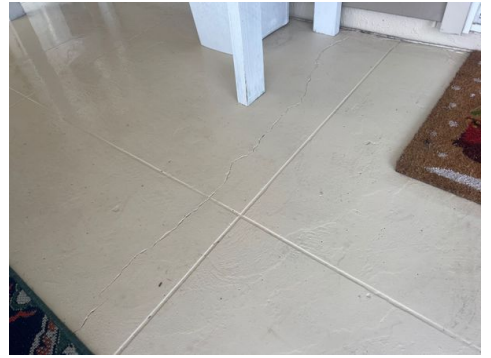
## 2.7.1 Porch/Patio, Screened-In Lanai

**MODERATE SETTLEMENT CRACKING**

Moderate settlement cracks were present on the concrete surface. If a concern, repairs are recommended to be conducted as deemed necessary by a concrete contractor.

Contact a qualified concrete contractor.

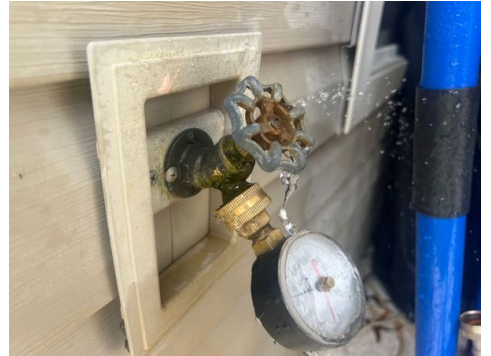
Right rear

**LEAK FROM VALVE STEM**

The referenced spigot was leaking from the valve stem area while under pressure. Repairs are recommended to be conducted as needed by a licensed plumber or other qualified person for proper operation.

Contact a qualified plumbing contractor.

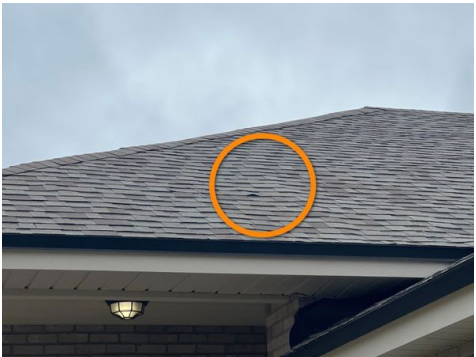
Right front

There were "lifted" or damaged shingle(s) present. This allows the shingle to be susceptible to damage from wind as well as possibly exposing underlying nails to rain. Repairs to properly "adhere" or repair any lifted or damaged shingles is recommended to be conducted by a roofing contractor.

Contact a qualified roofing professional.

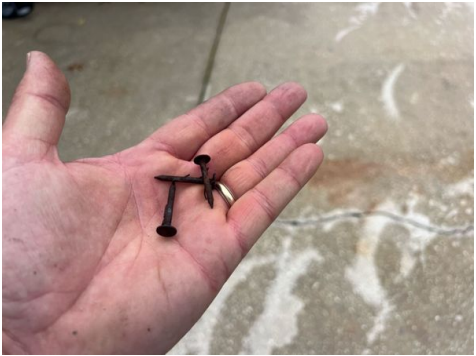
3.2.2 Roof Surface Condition

Construction debris was present on the roof surface at the time of inspection. Recommend having builder remove all construction debris from roof to prevent possible damage to the roof covering.

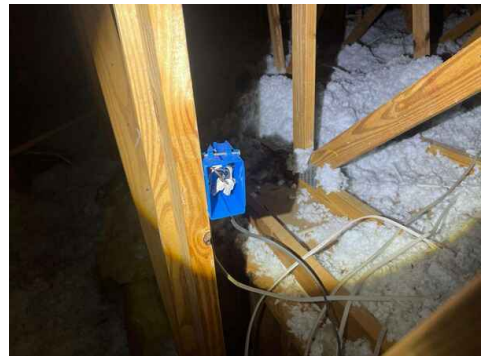
attic

**ELECTRICAL BOX - MISSING COVER**

Significant Defect

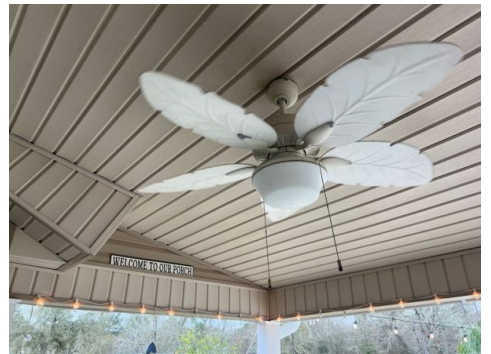
Rear

## 4.10.1 Ceiling Fans

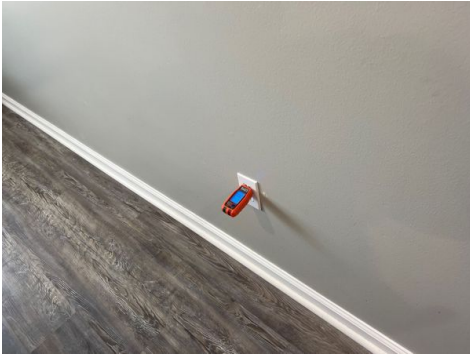
Dining Room

4.11.1 Receptacles

Contact a qualified electrical contractor.

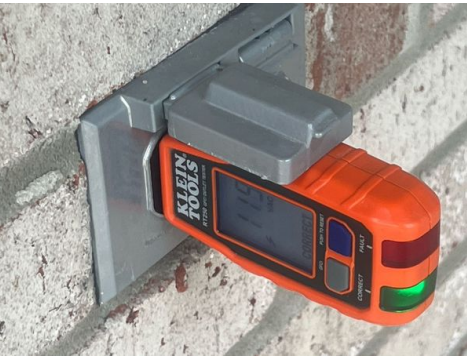
Front door

4.12.1 GFCI Protection

Contact a qualified electrical contractor.

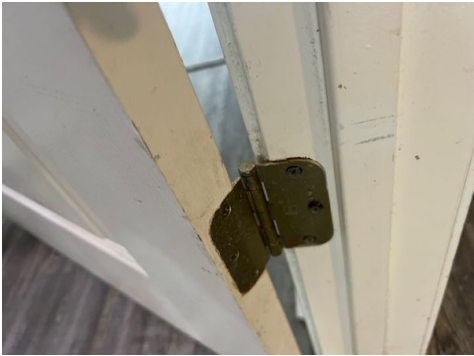
Master Bedroom

HINGE LOOSE

Loose hinge present in one or more doors. Recommend repair

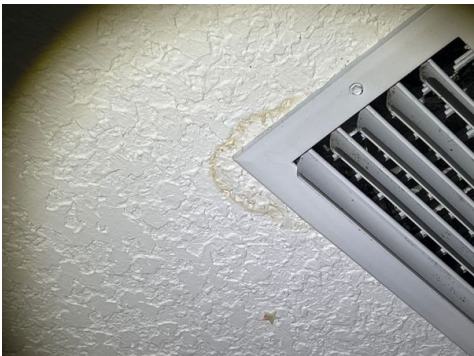
Front left bedroom

MOISTURE STAINING/DAMAGE PRESENT

Moisture stain(s) was present on the ceilings in the referenced areas. Although the area(s) was dry at the time of inspection, moisture stains should be monitored for future leaks. Recommend inquiring with the sellers about the stains as they would have firsthand knowledge of why the stain is present, and what repairs were carried out to address it. If they are unsure of the stains, a roofing contractor or plumbing contractor (as applicable) should evaluate and make repairs as needed. Repairs to any damage is recommended as needed by a qualified person.

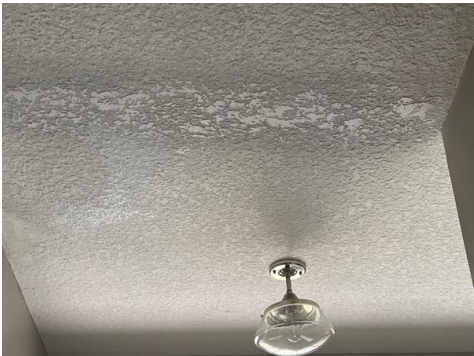
Foyer

PATCHED/REPAIRED AREAS ON CEILINGS

FYI - Patched or repaired area(s) were present on the referenced ceiling(s). These area(s) tested as dry at the time of inspection, and the reason for the repairs was undetermined. I recommend consulting with the seller(s) as to why the repairs were conducted along with obtaining any applicable invoices or records of the repairs.

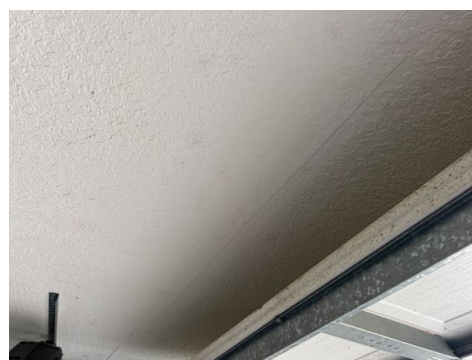
Garage

## 6.3.4 Ceiling Condition

Contact a qualified drywall contractor.

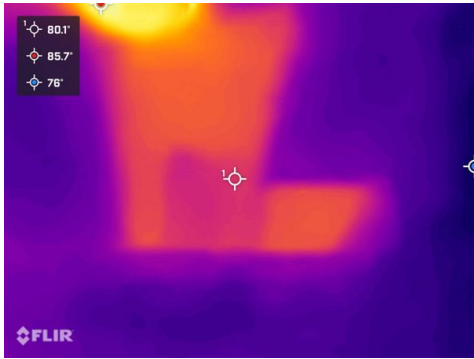
Master closet

6.3.5 Ceiling Condition

Contact a qualified insulation contractor.

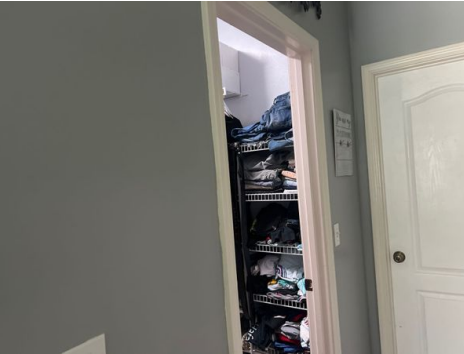
Master closet

6.7.1 Interior Doors

Contact a qualified handyman.

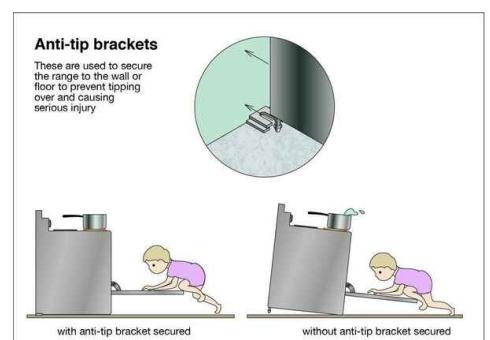
7.7.1 Oven/Range

### ANTI-TIP BRACKET MISSING/NOT ENGAGED

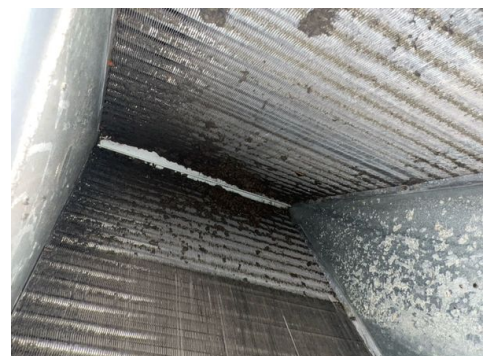
### 12.4.1 Interior Unit(s) - Split System

#### EVAPORATOR COILS DAMAGED/DIRTY

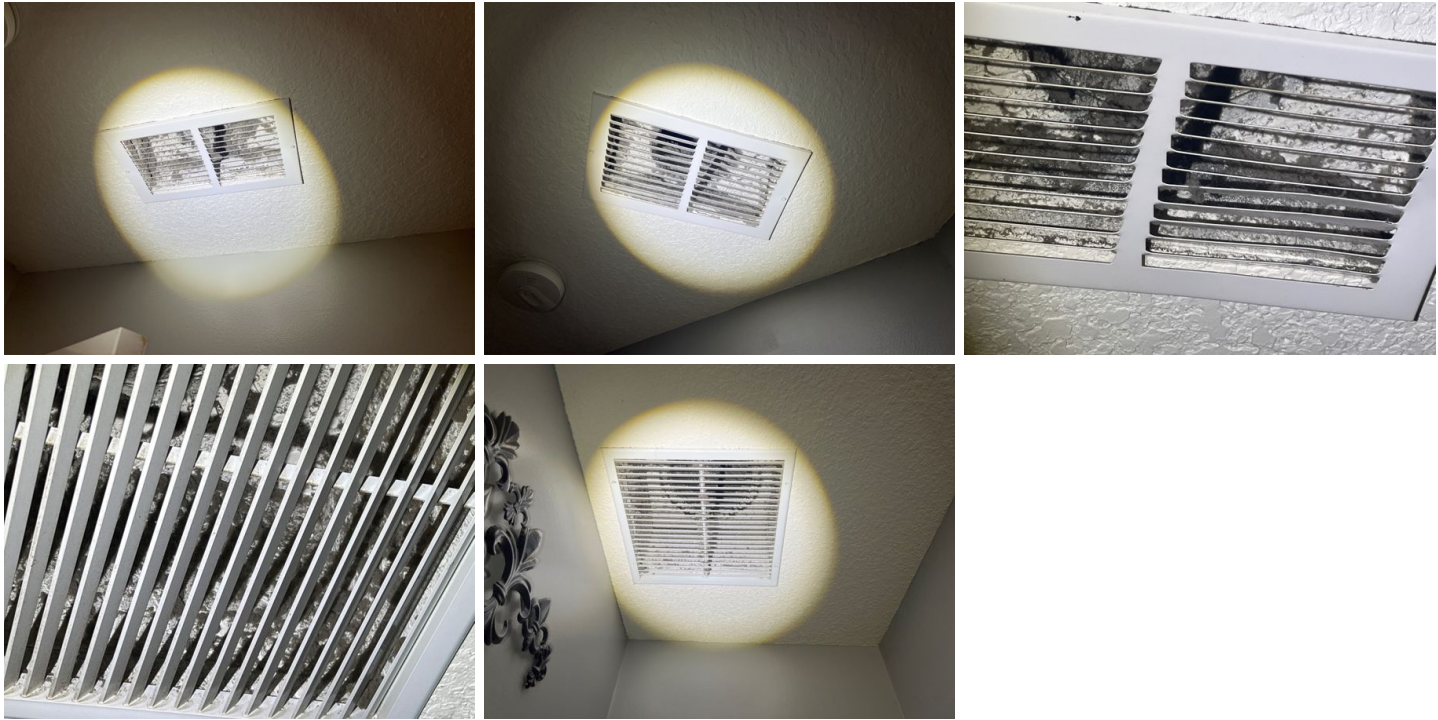
12.7.1 Air Supply/Registers

DUST IN RETURN PLENUM / DUCTS

Contact a qualified professional.
