# IRONCORE INSPECTIONS & ENVIRONMENTAL

## RESIDENTIAL PROPERTY INSPECTION

1234 Main Street  
Fort St. John, BC  
Client Name  
06/17/2026 – 9:00 AM

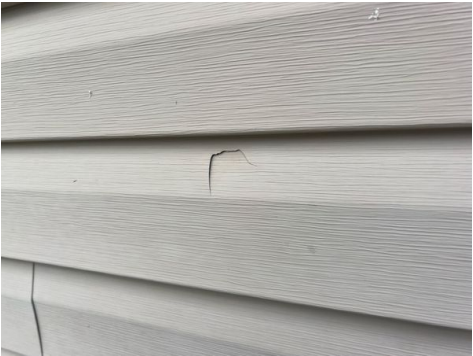
Right front

SIDING/TRIM DAMAGE PRESENT

Damage was present to the siding and/or trim in one or more areas. Repairs or replacement of damaged portions as deemed necessary by a siding contractor is recommended to prevent moisture infiltration.

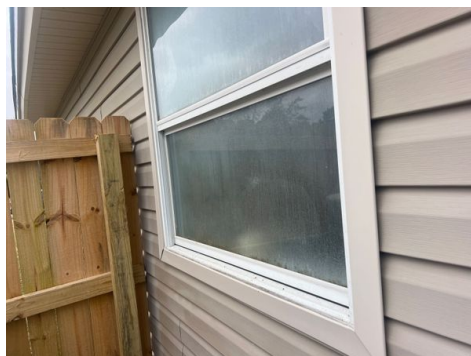
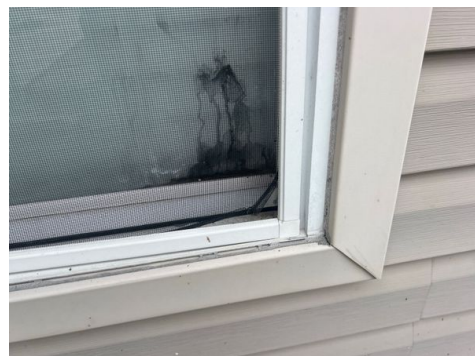
Rear

**MISSING/DAMAGED SCREENS**

There are one or more windows with damaged or missing screens. Recommend having a qualified contractor evaluate and repair or replace as needed. Recommend consulting with the seller to see if the screens are present and can be installed.

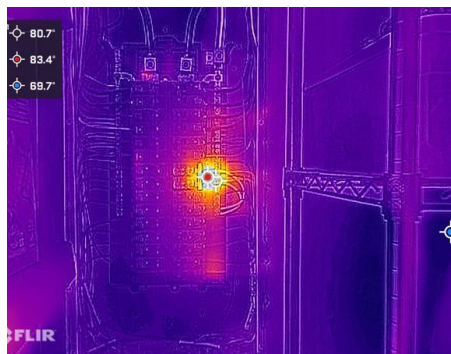
## General Info: No Hot Spots Observed with IR Camera

No hot spots or anomalies were observed in the electrical panel, under current loading conditions, during the inspection.

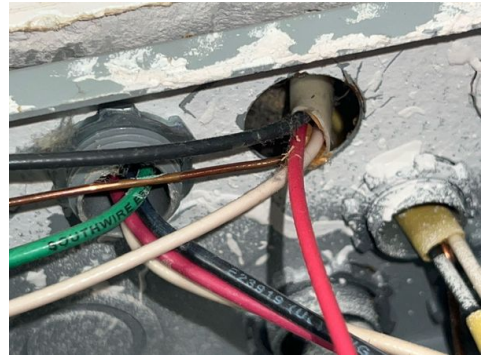
**MISSING/IMPROPER BUSHINGS**

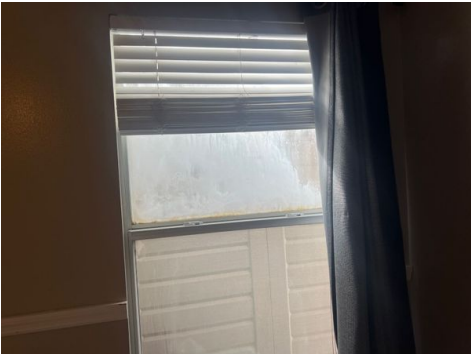
Left middle bedroom

SEAL FAILURE PRESENT

There were window(s) present with seal failure present. This is where the double pane glass loses its adhesion with the inner spacer, allowing moisture/debris in between the panes of glass. Seal failure can result in some loss of energy efficiency and can obscure visibility through the glass. Some windows may not show signs of seal failure due to desiccant in the glass spacer absorbing moisture in between the panes, as well weather conditions in the future (high humidity, etc.) may reveal more seals that are failed than what was observed at the time of inspection. A review of all windows in the home with replacement of any affected glass found is recommended to be performed by a window company or glazing contractor.

Contact a qualified window repair/installation contractor.

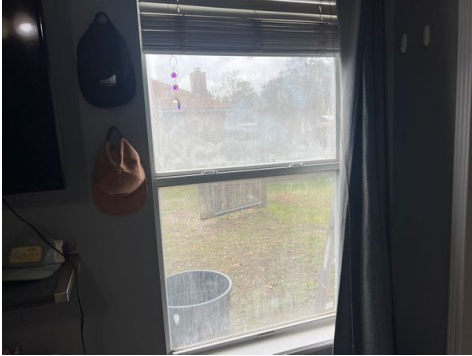
Left front bedroom

The window(s) in the referenced areas were stuck, painted shut, or otherwise inoperable. Repairs are recommended to be conducted as needed for proper operation by a window installation contractor or other qualified person.

Contact a qualified window repair/installation contractor.

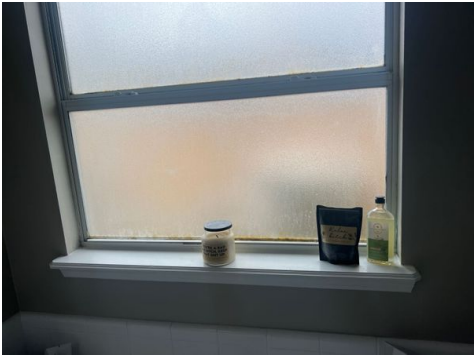
Master Bathroom

POSSIBLE SEAL FAILURE

There were windows present that showed potential indications of seal failure. Discerning between dirty windows and seal failure can be difficult when the seal failure is not visually obvious. Changes in conditions such as high humidity and temperature extremes can allow the glass to show signs of failure that were not visible at the time of inspection. If seal failure is a concern, I recommend having a glazing contractor to evaluate all the windows in the home.

Contact a qualified window repair/installation contractor.

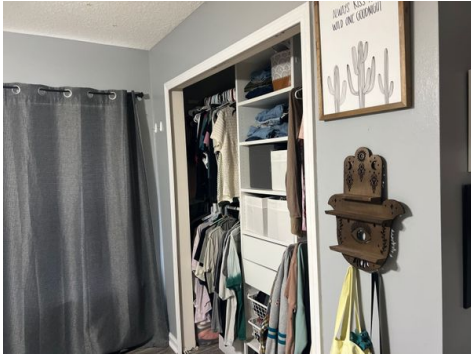
Front left bedroom closet

**FYI** - The door slab has been removed at the referenced area(s). The installation of a door slab is recommended to be conducted by a qualified person as desired.

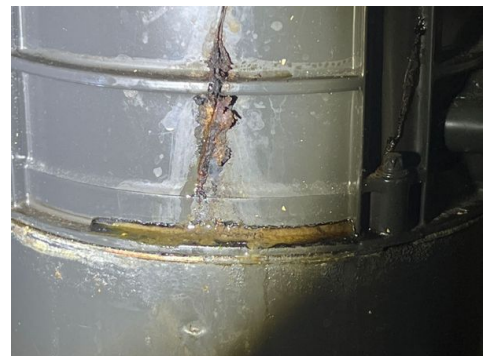
### DISPOSAL UNIT CRACKED

Disposal unit is cracked, and leaks when in use. Recommend repair/replace

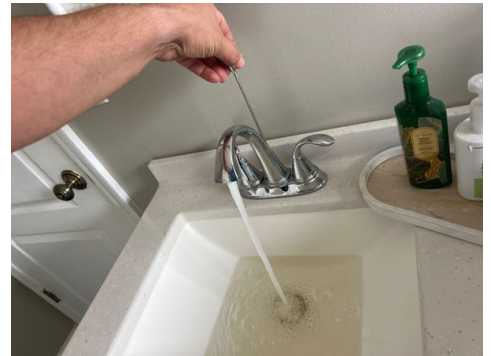
Master Bathroom

The pop-up stopper was not functioning properly on the sink, this could include it not being connected properly, not sealing, or other defects. Repairs are recommended to be performed as needed by a qualified person for proper operation.

Contact a qualified handyman.

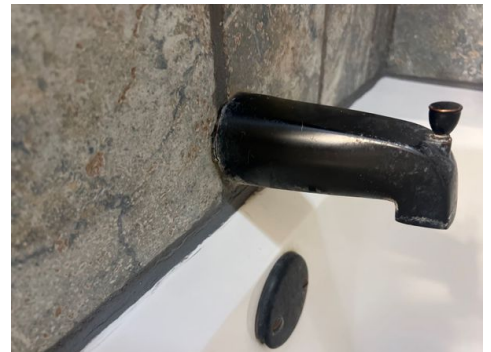
Guest bath

The faucet and/or faucet valve(s) were not sealed to the shower wall. This can allow for water infiltration behind the wall creating damage. Proper sealing of any and all faucets and valves is recommended to be performed by a qualified person.

Contact a qualified professional.

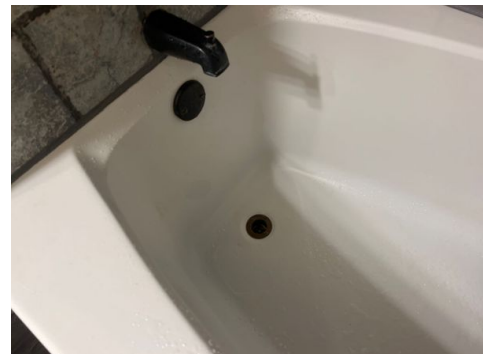
Guest bathroom

**STOPPER MISSING**

A stopper / pop-up was not present in the tub. The installation of a proper pop up is recommended by a qualified person.

Contact a qualified professional.

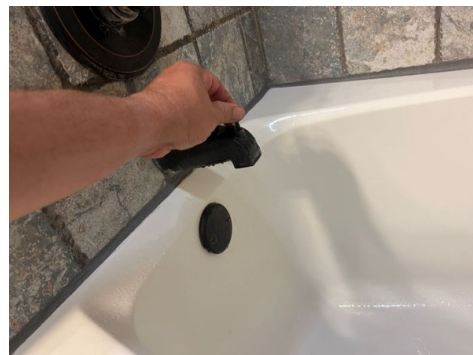
Guest bathroom

**DIVERTER DEFICIENCY**

Sporadic issue with shower diverter, was not functioning properly, preventing water flow from the showerhead (attempted use several times, occasionally needs to be help up to function). Repairs are recommended as needed by a licensed plumber for proper operation.

Contact a qualified plumbing contractor.

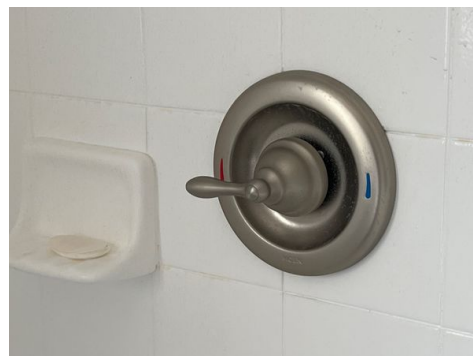
Master Bathroom

The faucet and/or faucet valve(s) were not sealed to the shower wall. This can allow for water infiltration behind the wall creating damage. Proper sealing of any and all faucets and valves is recommended to be performed by a qualified person.

Contact a qualified professional.

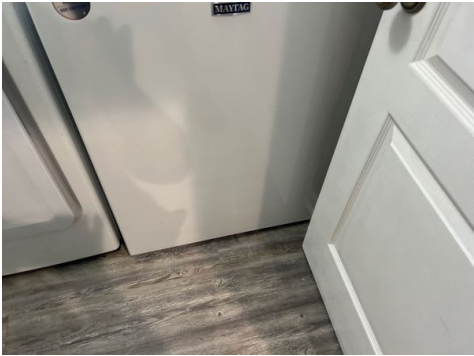
**WASHER DRAIN PAN RECOMMENDED**

**FYI** - Due to the laundry room's location being located over living areas, the use of a washer drain pan is highly recommended should the unit leak.

Contact a qualified professional.

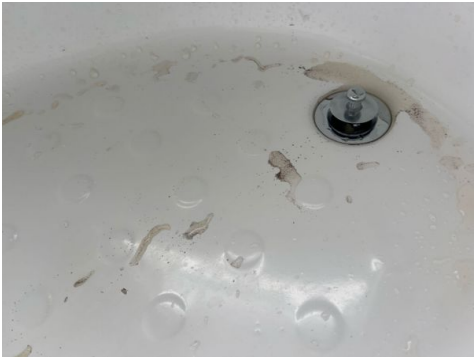
Master Bathroom

Sediment was present in the water. There can be many causes of this ranging from rusting elements in the water heater, excessive iron in the water supply, or even a crack in the main water line, pulling dirt into the potable water. Evaluation by a licensed plumber is recommended with repairs performed as needed.

Contact a qualified plumbing contractor.

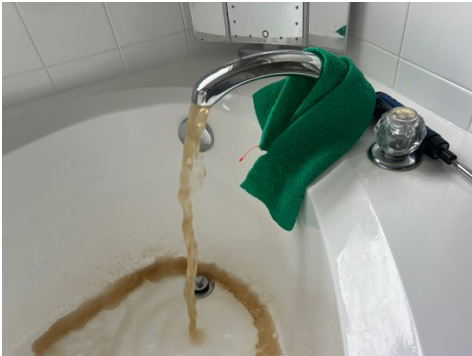
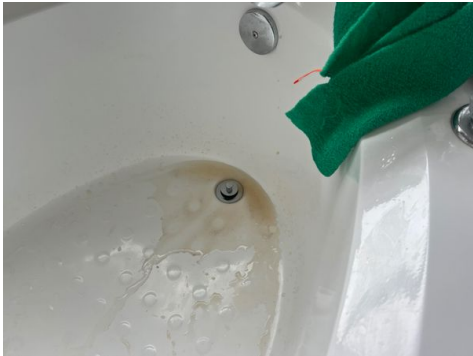
Master Bathroom

The water supply was discolored at the time of inspection. This may be associated with rust or sediment in the water heater or other deficiencies. An evaluation is recommended by a licensed plumber to determine why the water supply was discolored.

Contact a qualified plumbing contractor.

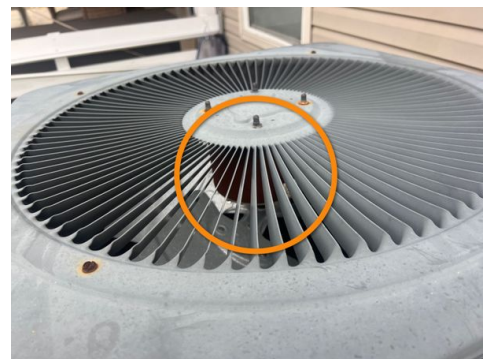
#### RUST ON FAN MOTOR/HOUSING

Signs of rust was found on the fan motor and/or housing. Recommend having a qualified contractor evaluate and repair or replace to prevent further corrosion and damage to the unit.

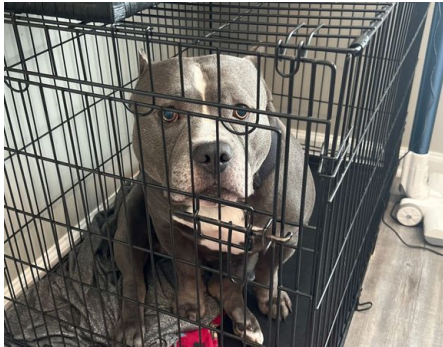
On site security is present, says  
he will be going with sellers
